MARYLAND PROFESSIONAL MOLD SERVICES LLC
POST OFFICE BOX 613
PASADENA, MARYLAND 21123-0613

Observations during the visual moisture and mold investigation

On Tuesday, November 10, 2009, we were contracted to investigate concerns about a past or present mold growth at:

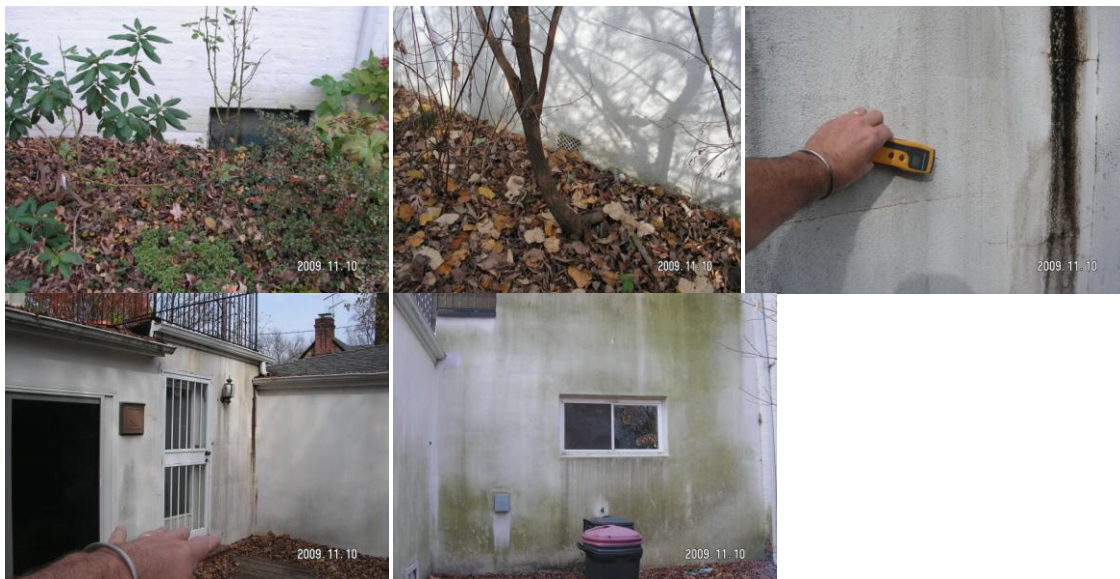
We began the investigation by examining the grading and exterior of the structure. The grading was very poor in many locations and is most likely leading to moisture or water problem on the inside of the home. The original portion of the home is brick and the rear addition is a stucco faced structure. It's difficult to tell with our hand-held moisture meters and even with the use of a thermal imaging camera, but there appeared to be areas of moisture behind some of the walls.

Structure is not my background; however some areas of the stucco wall sound very hollow when struck with your fist.

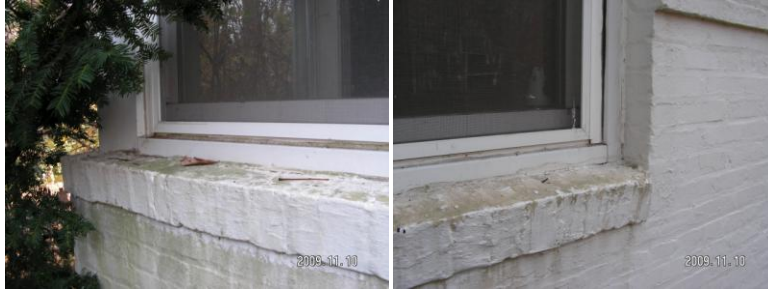
Many years ago the windows were replaced with vinyl replacement windows; however, the trim is in need of caulk.

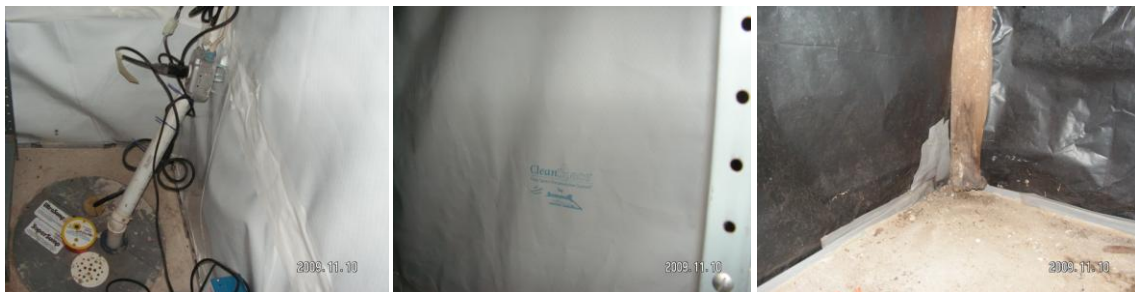
It became quickly obvious that this house has suffered from moisture problems from day one. Numerous attempts have been made to control the moisture intrusion including waterproofing paint, a retrofit interior drain tile system, plastic sheeting against the damp walls, and a battery backup on the sump pump.

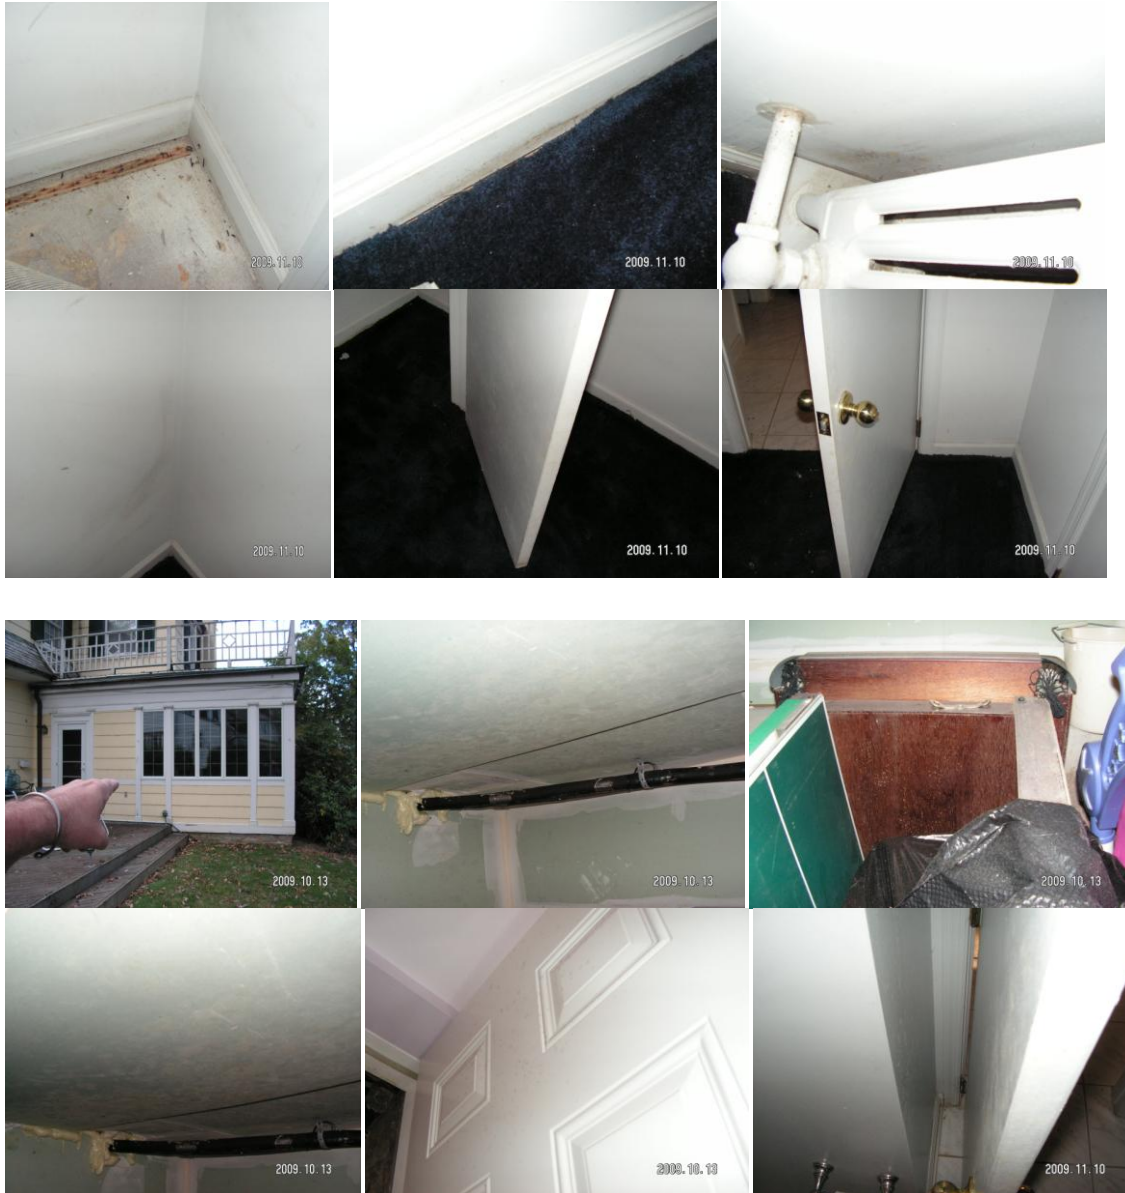
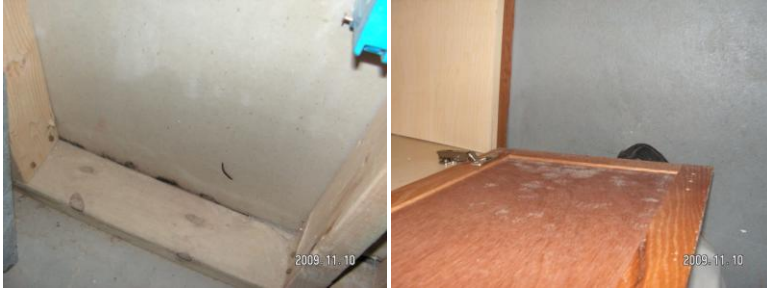
Visible mold growth, identified on site as [Aspergillus](#), could be found on almost every wall, door, or surface from the floor up to about 4 feet.

Although many attempts to waterproof this home have been attempted, we still have excessive humidity and vapor intrusion that has led to rampant mold growth throughout the basement. The best and most cost-effective way to address this basement would be to completely gut it by removing all horizontal and vertical building materials. Once the sheet rock is been removed, a determination can be made as to whether or not the studding needs to be removed. Once this has been accomplished, I would recommend that the plastic against the walls be permanently sealed onto the wall and into the waterproofing system. At this point an active dampness control system, radon system, can be installed to de-vaporized and depressurize the floor and walls.

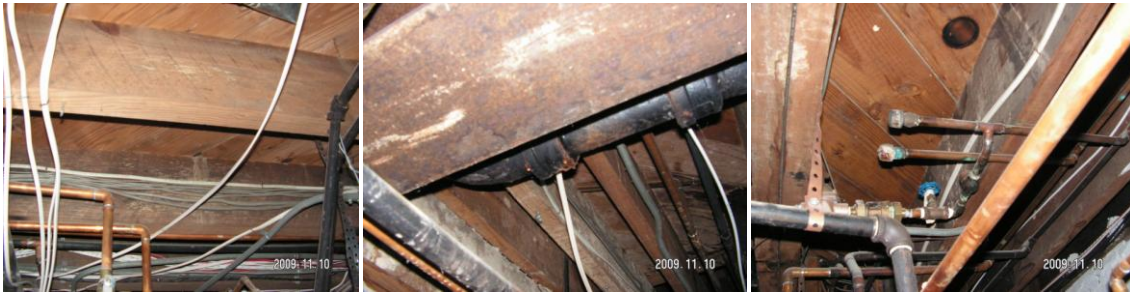
There are active plumbing leaks in the plumbing pipes and the sewer and drain.

First things first, contact a plumber to address the water leaks sewer drain line, second-floor tub, the old supply line caps.

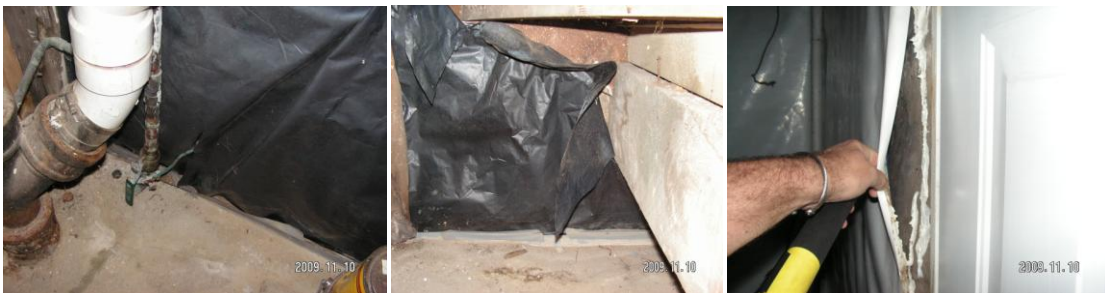
A waterproofing system has been retrofitted with plastic sheeting to control wall seepage and vapor intrusion. Unfortunately, the installers did not seal the plastic airtight to the wall and waterproofing system. This will of course allow vapor or moisture, as well as odor, to permeate the basement and contaminate the building materials.

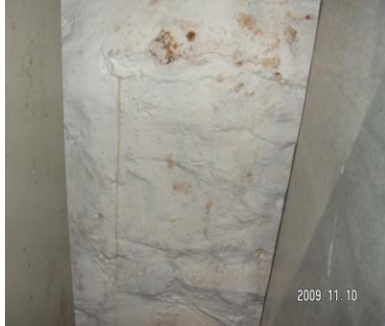
The basement walls have been painted with waterproofing paint. Stopping moisture is very important; however it should have been done from the outside before painting the walls.

The use of the waterproofing paint can assist with water vapor. The paint that was used was not designed for this application. It was designed for new and

dry walls and allows mold to grow on the subsurface. These walls should be scraped and wire brushed and repainted with a paint containing an anti-microbial compound, unless the plastic can be air sealed, which is what I recommend.

Where it is impossible to put the plastic sheet against the foundation wall, recoat these walls with Zinsser Watertite.
Following the manufacturer's instructions apply Zinsser Watertite to the foundation wall.

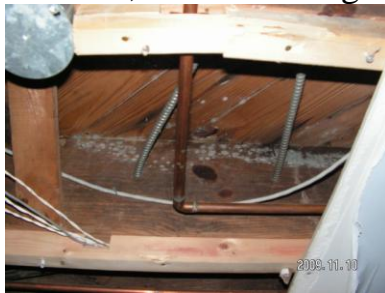
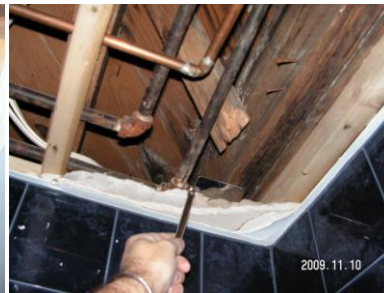
An apparent plumbing leak, in the basement bathroom, has been repaired; however, visible mold growth remains.

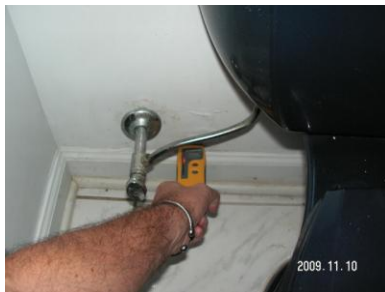
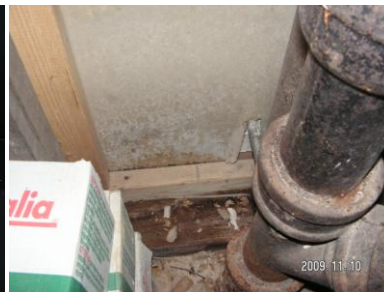
The sheet rock wall behind the toilet shows 100% moisture and exhibits black mold identified on site as [Stachybotrys](#).

If any sheet rock is to be replaced, use the following Georgia-Pacific product:

Georgia-Pacific makes a fiberglass faced sheet rock product that would be perfect for this location. Densarmor

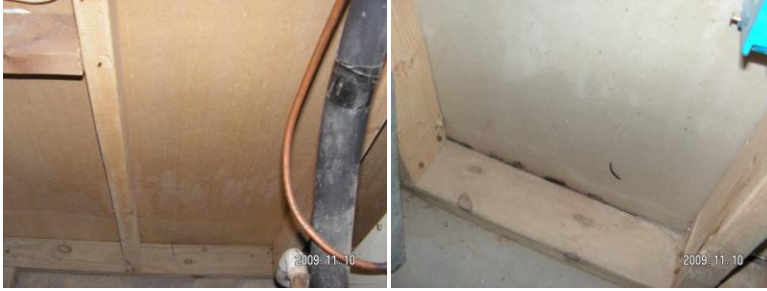
The unfinished room that contains the lower air handler has visible mold growth all along the walls, including areas of Stachybotrys.

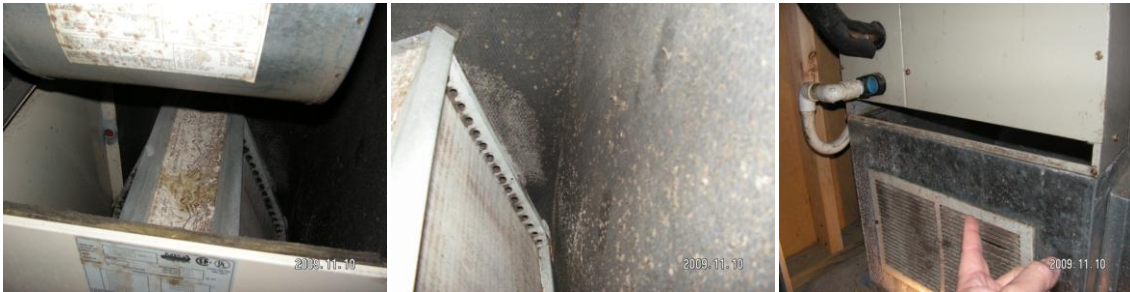
When we examined the lower air handler, we found it to be fully contaminated with mold growth and located with a cold air return directly over a hole in the floor which allows musty odors and mold to be drawn directly into the air handler.

The air handlers are contaminated with active and dormant mold growth. Visible mold growth is common in air handlers and can be bio-cleaned, in some circumstances, and the unit salvaged. The configuration of this system could be contributing to the rapid mold growth as well as the poor filter practice. Consider using a disposable pleated filter with a Merv rating of 11 to 14.

Check with your mold remediation contractor or hire a licensed HVAC contractor to decontaminate the air handlers and the ducts.

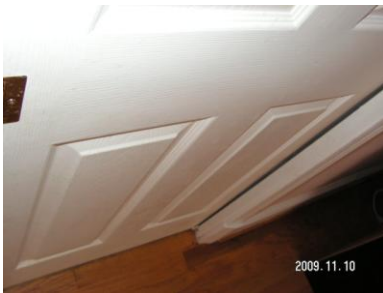
We continued investigation onto the first floor and found mold grows on the pocket doors between the dining room and the kitchen.

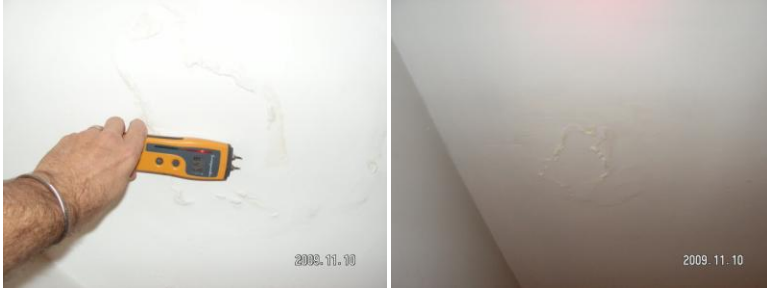
Also on the first floor in the room, directly below the second floor bathroom, that I'll identify as a library, [efflorescence](#) could be seen on the ceiling plaster from a leak in the bathtub above.

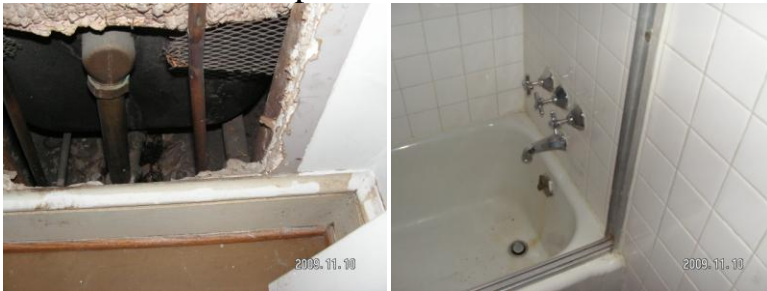
When I examined the bathroom above, I found the water was running in a tub and drain pipes in the tub was leaking into the ceiling. There are no shutoff valves for the tub supply lines so I shut the valves off as tightly as I could and water seemed to stop.

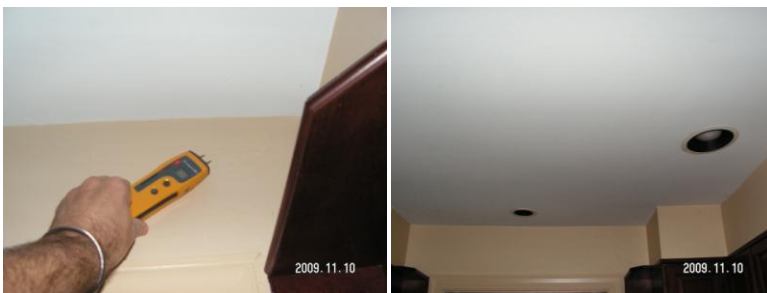
We continued investigation on the first floor and found past water damage in the ceiling of the second kitchen. This area has been examined with a moisture meter and numerous puncture holes were left in the ceiling to attempt to quantify the water damage. We followed up on that investigation and found visible water damage on the exterior facing wall of the second kitchen. Water stains could be seen through the wall tiles.

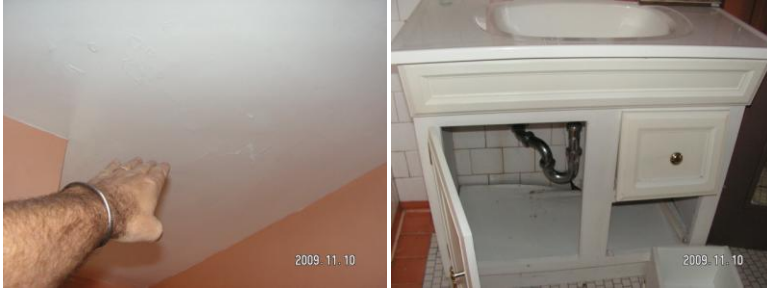
We continued investigation onto the second floor and immediately began in this small unimproved bathroom above the aforementioned second kitchen. Evidence of plumbing damage to the vanity was obvious; however, an active wet area could be found in the ceiling and the wall behind the toilet.

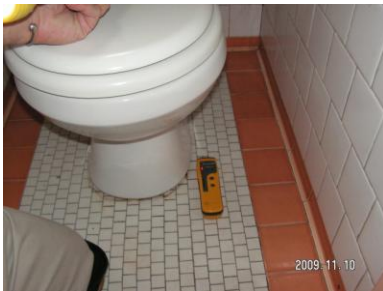
The wax ring under the toilet may be deteriorated as well, but due to all the moisture around it's difficult to isolate that spot.

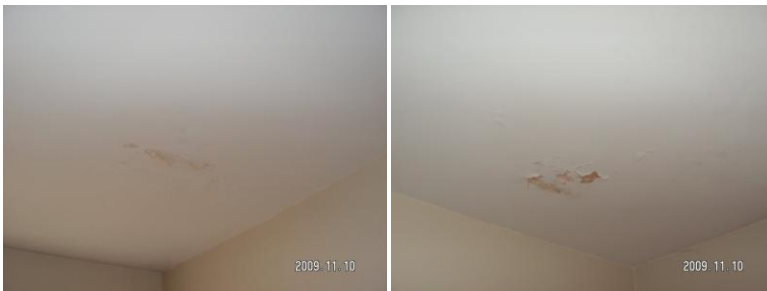
We continued the investigation into the center room, next to the attic access, and found multiple active areas of ceiling damage, mold, efflorescence from a roofing leak. Once again using our hand-held moisture meter and a thermal imaging camera, we found these areas to be actively wet

Have a licensed roofing contractor examine the various roof systems on this home. Since during our inspections we found wet and active water leaks in multiple areas of the ceiling, a licensed roofer should examine this roof and certify its integrity.

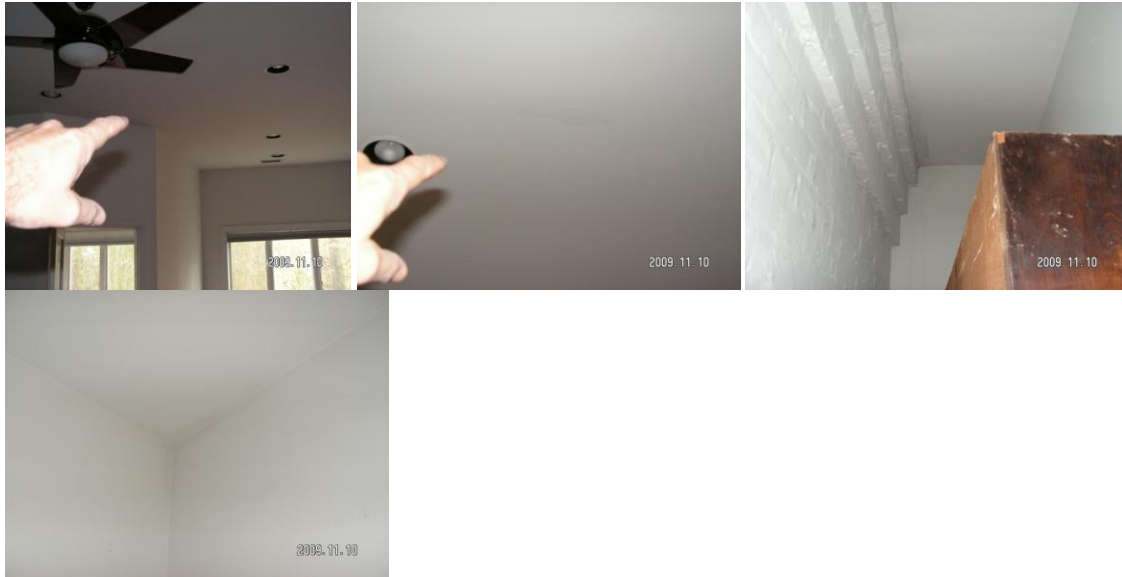
We continued investigation through this second floor, which included the bathroom with a leaking bathtub, and then finally into the master bedroom which is located in an addition to this house. Evidence of past water damage to the ceiling was evident; however, was dry during our inspection. We continued through the master bath and into the final room that leads to the outside balcony. The corner of that room as well as the closet show evidence of past water leaks in damage to the ceiling. During our investigation these areas were dry.

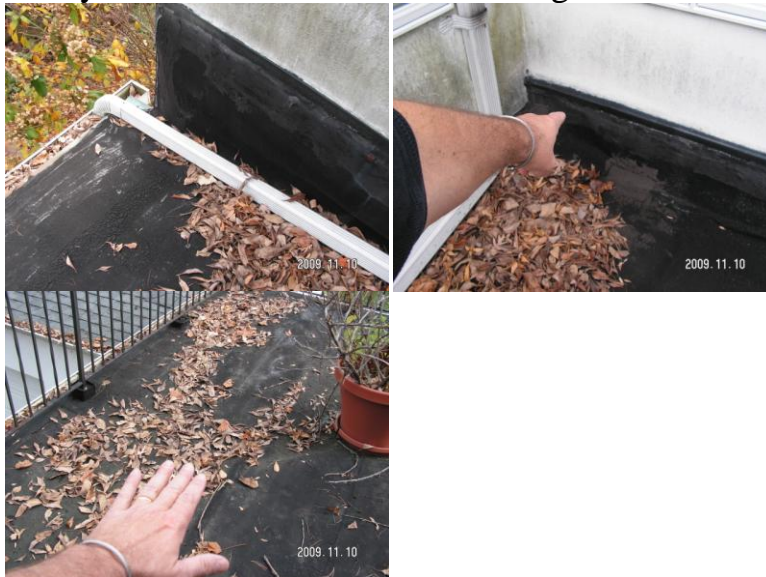
We took advantage of the balcony and walked the flat and partially flat roofs on the very back of the home and found them to be in questionable condition. I am not a roofer but I would strongly recommend a roofing contractor to certify all of the roofs on this building.

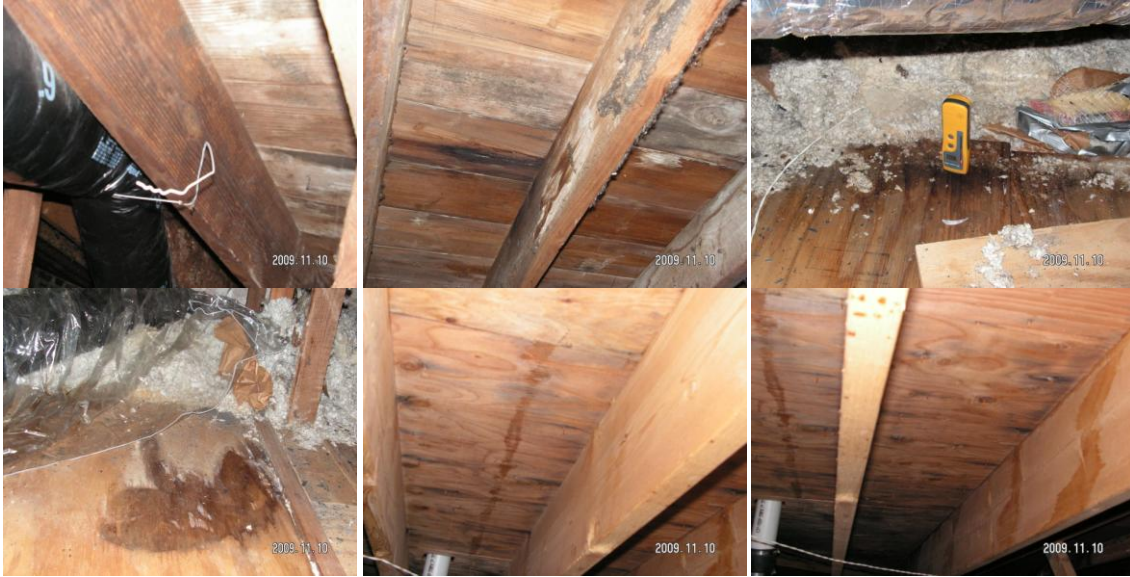
We continue the inspection into the attic and found evidence of water leaks in a few portions of this roof. The ceiling leaks over the center room were evidenced by damage to the floor; however, the ceiling leak in the unimproved bathroom could not be readily determined and will need a roofing contractor.

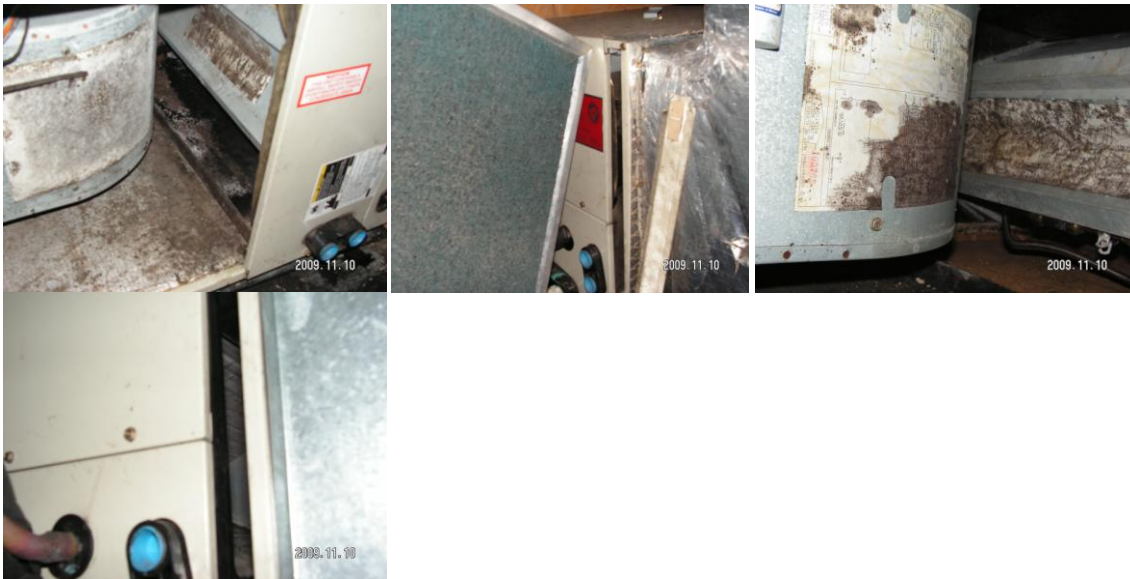
We opened and evaluated both air handlers in the attic and found them to be fully contaminated with mold growth.

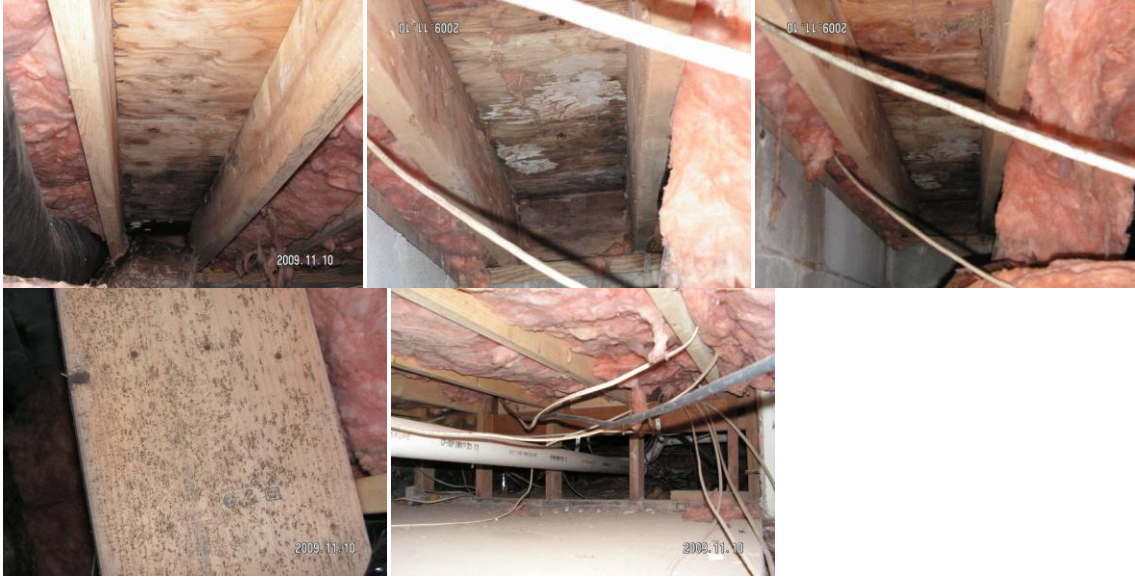
At this point we entered and examined the crawlspace. We found this crawlspace to be wet and without a vapor barrier in some locations. Installation is fallen in a number of places and visible mold growth is prevalent throughout. The room with washer and dryer shows damage to the joists as well as the subflooring likely due to the exterior wall we had mentioned earlier.

A mold or remediation contractor should also decontaminate the crawlspace after any needed structural repairs have been accomplished. This will include the removal of the affected insulation to determine the extent of the water intrusion into the building. Because of the water intrusion, likely the

aforementioned corner and downspout area, will need to be rectified to prevent recurrence.
